Making Better Impressions A Troubleshooting Guide

Course Author: 3M ESPE

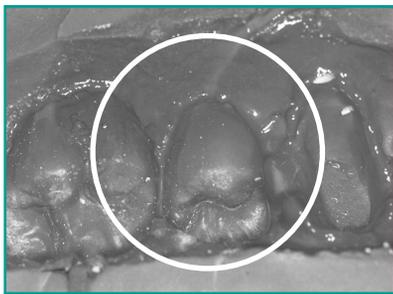
Surface Inhibition/ Slow Set

Visual Appearance: Impression not completely set. Tacky to the touch.

Result: Inadequate surface detail on stone reproductions, poor fitting crowns.

Contaminated wash material

Sulfur in latex gloves or rubber dam inhibits the setting reaction of VPS, but does not affect polyether impression material.

Wear nitrile gloves or gloves proven not to inhibit set of VPS impression materials immediately prior to making final impression.

If contamination suspected, scrub affected area with diluted hydrogen peroxide.

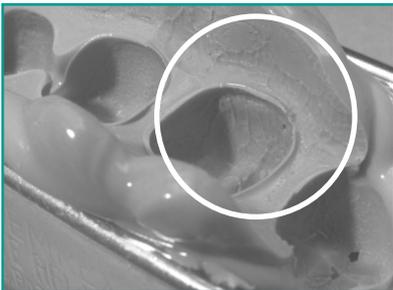
Surface inhibition

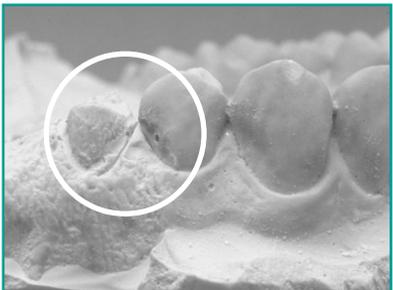
Die stone with impression material residue

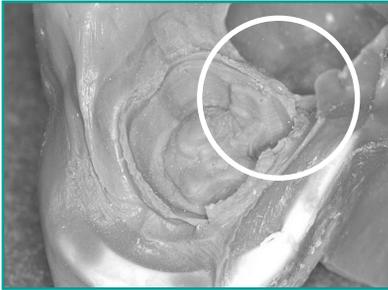
Voids on Margin

Visual Appearance: Voids on margin or around prepared teeth.

Result: The fit and function of the final restoration may be compromised.

Poor retraction and syringing technique

Air incorporated in intraoral syringe or while filling impression tray.

Improper syringe technique.

Blood saliva contamination around prep.

Poor retraction around prep.

Retraction cord not left in place adequate amount of time so that no blood or saliva are present.

Front load syringe by inserting mix tip directly into intraoral syringe and keep mix tip immersed in heavy body material while filling the tray.

Keep syringe tip immersed in wash material to avoid entrapping air.

Good retraction technique; rinse and dry prep area.

Good retraction technique; consider two-cord retraction to displace tissue and control fluids.

Good retraction technique; leave cord in sulcus until no blood or saliva are present before syringing the light body impression material. Consider two-cord retraction.

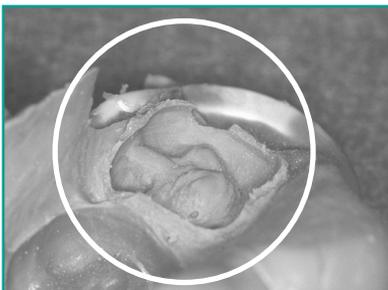
Tearing at the Margin

Visual Appearance: Tearing visible on the margin of the preparation.

Result: Short crown margins and/or open margins.

Marginal tear

Poor retraction technique.

Surface inhibition.

Slow -setting material.

Early removal from mouth.

Improve retraction and where appropriate, use two-cord technique.

For VPS, avoid contamination from sulphur or methacrylate. For Polyether, avoid epinephrine or iron III sulphate because setting time could be compromised.

Follow manufacturer's setting time recommendation.

Check expiration date of material.

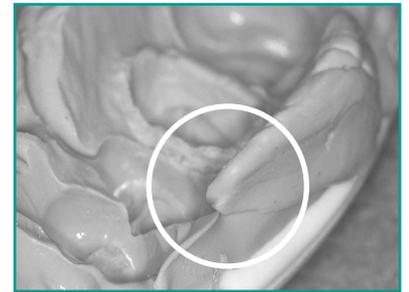
Delamination

Heavy body and light body materials not blending, or adhering together.

Result: Indirect restoration will not seat properly.

Poor bond between heavy body/light body materials

Blood/saliva contamination around prep.

Inadequate retraction of sulcus around prep.

Exceeding the working time of the impression material.

Rinse and dry prep area just prior to making impression.

Good retraction technique with proper moisture control and proper tissue retraction.

Follow manufacturer's working time specifications.

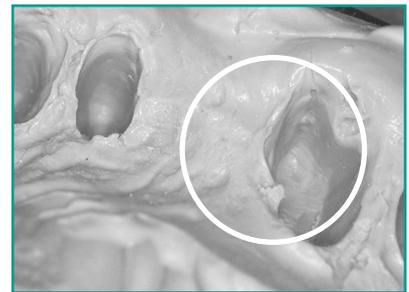
Lack of Impression Detail

Muted detail reproduction and inadequate margins.

Result: Crowns may be too tight or small and extensive occlusal adjustments may be required.

Inadequate retraction

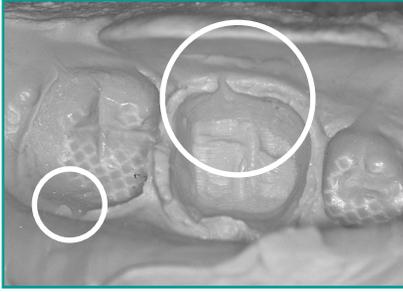
Inadequate Capture of Margins

Visual Appearance: Incomplete margin. **Result:** Short crown margins and/or open margins.

Void caused by syringe technique

Keep syringe tip immersed while syringing.

Gently stir while syringing.

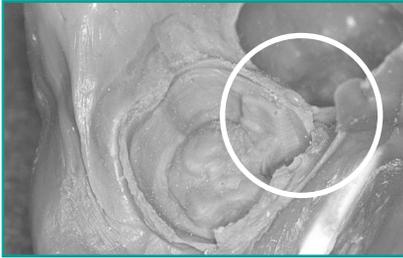
Air bubble on margin

Inadequate coverage of marginal area with light-body impression material.

Fluids such as blood or saliva present within the sulcus.

Tearing of margin.

Exceeding the working time of the material.

Good retraction technique.

Maintain a clean and dry field.

Check manufacturer's instructions for working and setting times.

Follow the manufacturer's working time specification.

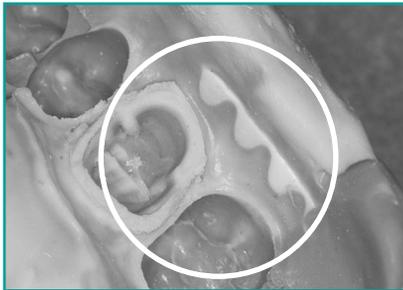
Improper Tray Seating

Visual Appearance: Burn-through of light-body impression material. Impression tray exposed.

Result: Crowns are too tight, too small, or rock when seated; Tight-fitting crowns.

Contact with impression tray

Prepared teeth contacting the sides or bottom of impression tray.

Tooth contact with the preset tray material when using the two-step technique.

Tray seated too quickly or forcefully.

Tray movement or rocking during the impression.

Weaker plastic trays can allow deflection of the tray, which may rebound upon removal.

Avoid contact of teeth with any surface of the tray.

Test various tray sizes to ensure proper size.

Relieve the heavy-body impression material to ensure a 2–3mm space.

Slowly position tray into patient's mouth.

Use passive pressure to immobilize the tray for the recommended set time.

Use a stiffer, more rigid stock tray.

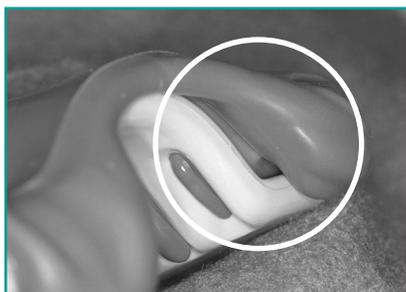
Poor Bond of Impression Material to the Tray

Visual Appearance: Impression pulling away from the sides/bottom of tray.

Result: Crown(s) may not seat fully, or require excessive occlusal adjustment.

Separation of material from tray

No tray adhesive used.

Incompatible tray adhesive used.

Inadequate drying time for tray adhesive.

Use appropriate tray adhesive.

Follow manufacturer's instructions for application and drying time.

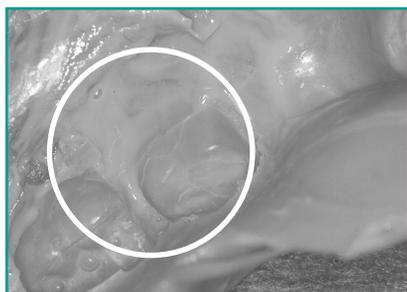
Inadequate Mix

Visual Appearance: Nonhomogeneous mix.

Result: Slow-setting impression material.

“Streaky” inadequate mix

Improper ratio of catalyst to base.

Mix tip not attached correctly.

Air in the 50 mL cartridge.

Bleed cartridge prior to attaching mix tip.

Use manufacturer’s recommended mix tip.

Bleed cartridge to ensure equal catalyst/
base expulsion.

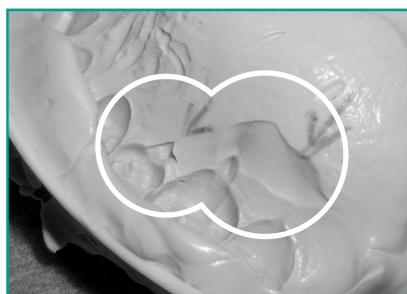
Facial–Lingual Pulls

Visual Appearance: V-shaped void, trough-like.

Result: Failure to capture complete and accurate dentition.

Lingual pulls

Improper tray seating.

Improper syringe technique.

Too little material.

Seat tray slowly.

Follow manufacturer’s working time.

Use proper syringe technique.

Use more material.
