# Uncompromised quality

## A case study integrating SDR in composite restorative techniques

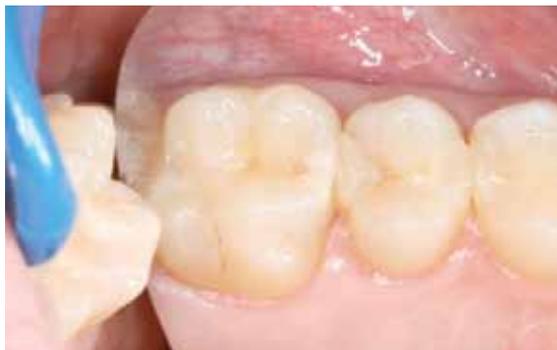
**Figure 1: Initial situation: old composite fillings with recurrent caries in teeth 25 and 26**

A 23-year-old male patient presented for a follow-up examination. Recurrent caries was found under composite fillings in teeth 25 and 26 (Figure 1). Bitewing radiographs confirmed the diagnosis. A cold test showed both teeth were vital.

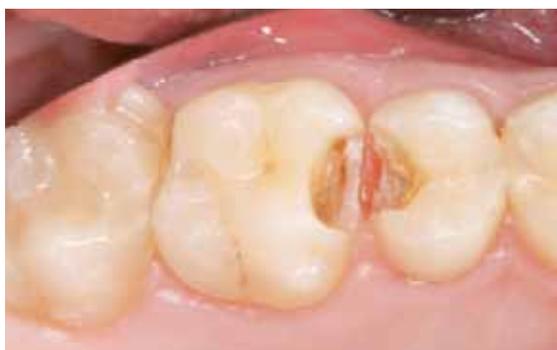
**Figure 2: Situation after composite filling removal and prior to caries excavation**

At the treatment visit, after infiltration anaesthesia, the two old composite fillings were removed with a cylindrical diamond bur, taking care not to damage the residual sound tooth structure (Figure 2). This was followed by caries excavation, using round ceramic burs and a caries-detecting solution, and final cavity preparation, using a fine-grit diamond bur (all preparation instruments: Komet, Germany).

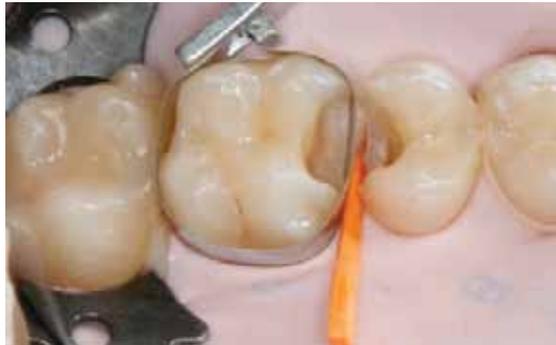
**Figure 3: Rubber dam and metal matrix applied to tooth 26**

After rubber dam placement over teeth 24 to 27, a metal matrix band was applied to tooth 26. A wooden wedge (Kerr Hawe, Switzerland) was used to separate the teeth and seal the cavity (Figure 3).

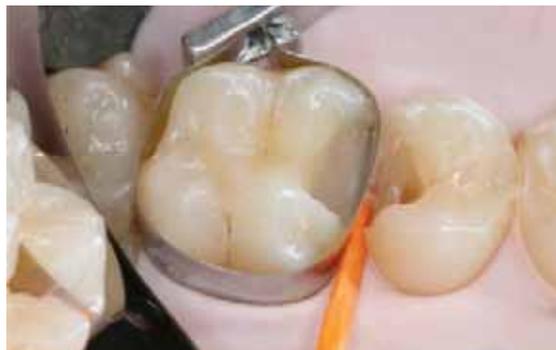
**Figure 4: Situation after bulk placement of SDR**

To replace the missing dentin and part of the cervical enamel, SDR was bulk-placed directly from the Compula into the cavity and polymerised for 20 seconds (Figure 4).

It is important to begin dispensing SDR at the deepest point of the cavity, extruding it at a steady pressure, and always keeping the thin metal tip of the Compula, which greatly facilitates void-free filling, immersed in the material extruded. SDR self-levels within a few seconds and can then be light-cured.

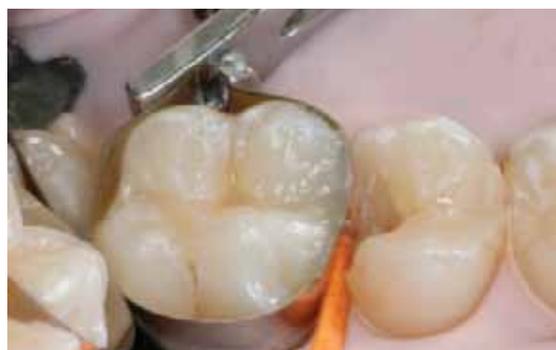
**Figure 5: Occlusal restoration of tooth 26 with Tetric Evo Ceram**

The next step was to complete the occlusal third of the filling with the composite Tetric Evo Ceram shade A2 (Figure 5). The occlusal surface was restored as accurately as possible, using composite modelling instruments. Excess material was removed. The composite was light-cured for 20 seconds prior to wedge and matrix removal, and additionally afterwards. Prior to placing the adjacent restoration, the proximal filling margins and the mesial marginal ridge were finished and smoothed, using a long, pointed, fine-grit diamond (Figure 6).

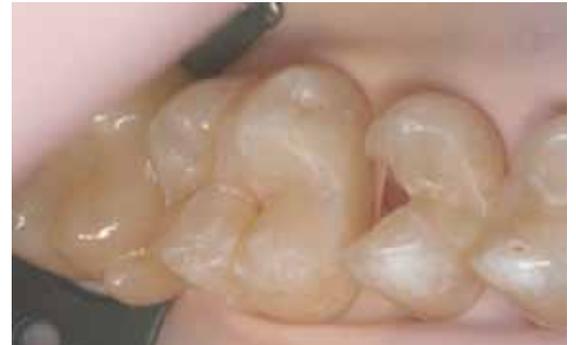
**Figure 6: This interproximal view of tooth 26 shows a void-free restoration with excellent marginal integrity and seamless transition from composite material to tooth structure**

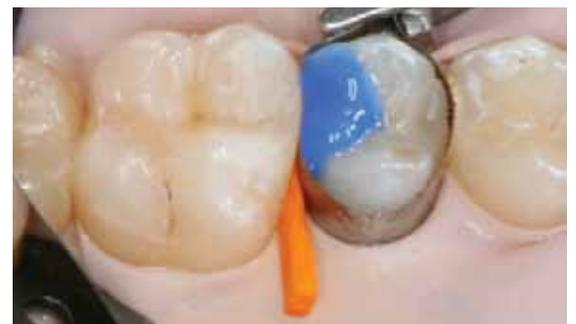
**Figure 7: Matrix and etchant applied to tooth 25, after finishing the filling margins on tooth 26**

The metal matrix was then applied to tooth 25. The matrix band was adapted to the contour of the filling in tooth 26 with a plugging instrument and tightly secured with a wooden wedge to obtain good proximal contacts (Figure 7).

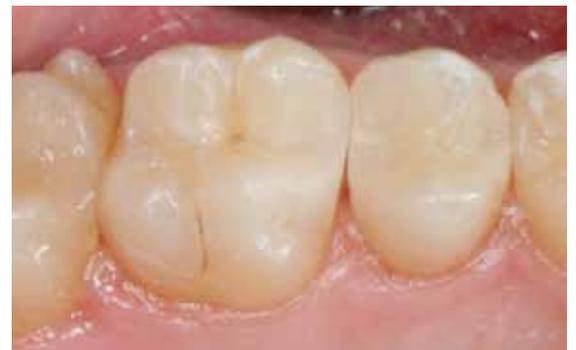
**Figure 8: Final composite fillings: both function and aesthetics were successfully restored**

After rubber dam removal, the restorations were finished, beginning at the margins in tooth 25. Short, pointed (bullet-shaped) and concave fine-grit diamonds with rounded tips were used for occlusal contouring, i.e. eliminating any occlusal interferences and checking static and dynamic occlusion. Finally, the restorations were polished to a high shine, using one-step composite polishers, polishing brushes and a polishing paste (Optrapol, Ivoclar Vivadent) (Figure 8).
