# VITA ENAMIC®

Technical and scientific documentation

Date of issue 08.16

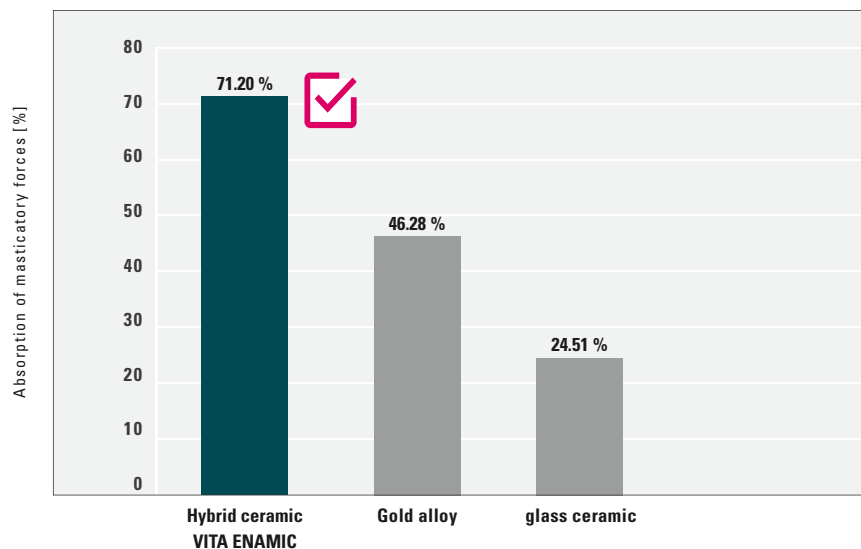
#### Absorption of masticatory forces compared to zirconia (ZrO<sub>2</sub>)

Material class	Modulus of elasticity [GPa]	Force transmission (N)	Absorption of forces (%) compared to ZrO <sub>2</sub>
Zirconia	210 GPa	641.8 N (SD 6.8)	
glass ceramic	96 GPa	484.5 N (SD 5.5)	-24.51 %
Gold alloy	77 GPa	344.8 N (SD 5.7)	-46.28 %
VITA ENAMIC hybrid ceramic	30 GPa	184.9 N (SD 3.9)	-71.20 %

The values of force transfer to the simulated periimplant bone determined in this test setup show that a relatively elastic material, such as the hybrid ceramic - compared to the comparatively stiff zirconia - absorbs or reduces forces (70 percent). In addition, VITA ENAMIC - compared to glass ceramic and gold - also reveals a higher capacity of absorption of masticatory forces.

Monolithic crowns made of materials, such as zirconia, glass ceramic, gold alloy and the VITA ENAMIC hybrid ceramic were fabricated for various test series. To simulate the transfer of forces to the periimplant bone, the crowns were placed on a sterilized implant abutment (pin) in the chewing simulator/robot, which was fixed on a platform equipped with sensors. The fixed crowns (three crowns of each type of material were tested) were subjected to dynamic loading by means of chewing simulation (100 cycles). The forces transferred to the simulated, periimplant bone within the scope of dynamic loading, were recorded and evaluated statistically. The chart of results below shows specific types of materials.

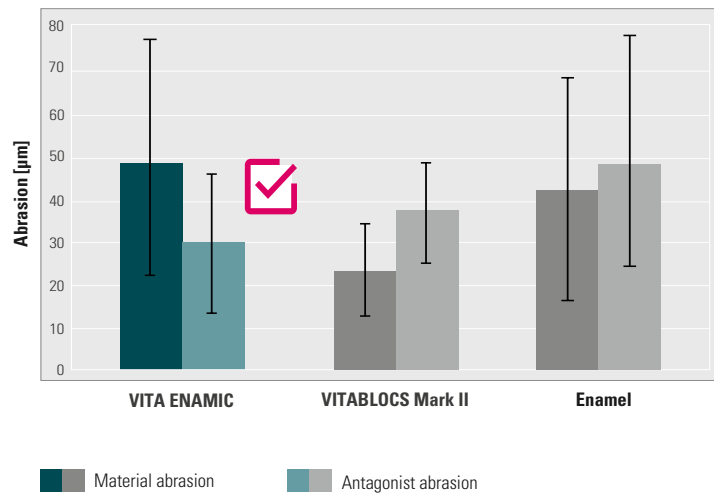
##### c) Result

The abrasion level of VITA ENAMIC is 49 µm. The level of abrasion to the antagonist enamel caused by VITA ENAMIC is 30.2 µm. VITABLOCS Mark II causes a slightly higher level of abrasion to the antagonist of 38.1 µm. As a control group, the abrasion of enamel to enamel was measured in the study. The goal with VITA ENAMIC was to further improve on the antagonist-friendly properties of VITABLOCS Mark II without abandoning the ceramic behavior of the material.

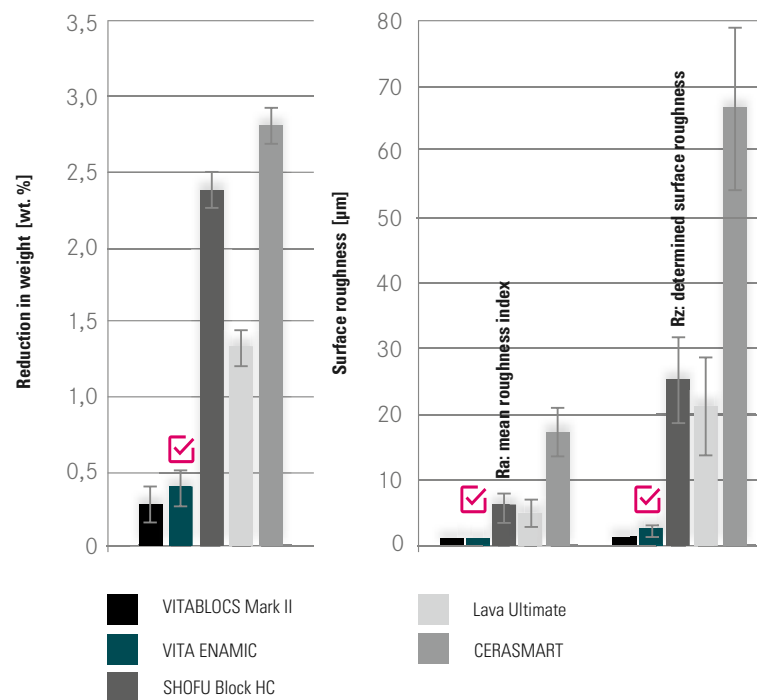
#### Loss of weight and surface roughness following toothbrushing wear test.

**Abb. 1** Averages for weight loss and surface roughness after toothbrushing wear on the basis of 5 samples per material. The lower the parameters Ra and Rz, the smoother the surface.

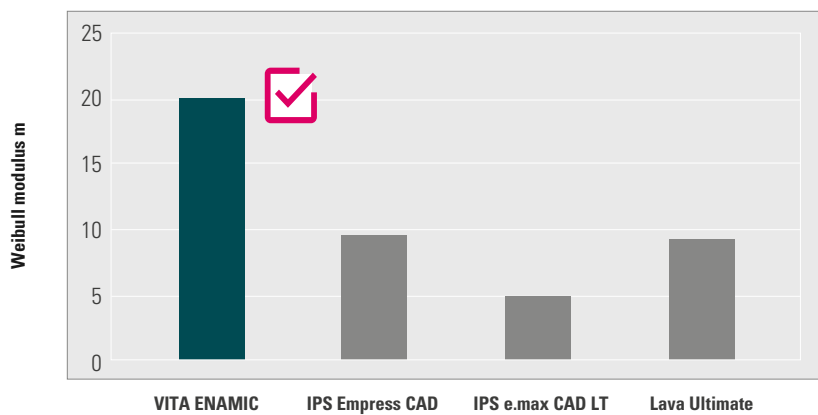
### c) Result

Of the materials measured in this test, VITA ENAMIC offered the greatest reliability. A Weibull modulus of 20 was achieved. When evaluating the Weibull modulus, the flexural strength (in-house measurements of VITA R&D: VITA ENAMIC: 153.82 MPa [SD 7.56 MPa], Lava Ultimate: 188.42 MPa [SD 22.29 MPa], IPS Empress CAD: 157.82 MPa [SD 17.33 MPa], IPS e.max CAD LT: 344.05 MPa [SD 64.5 MPa]) should always also be taken into account.

The Weibull modulus was determined based on the strength values of bending bars. "Using a theory developed by Weibull, based on the concept of failure of the weakest link, the strength distribution of ceramic materials can be described effectively in mathematical terms. [...] If the distribution parameters are known, a clear correlation can be drawn between the load and the probability of a fracture"<sup>1</sup>; in other words, a high Weibull modulus indicates consistent material quality. Together with the high load capacity values, it is an indicator of the reliability of a material.

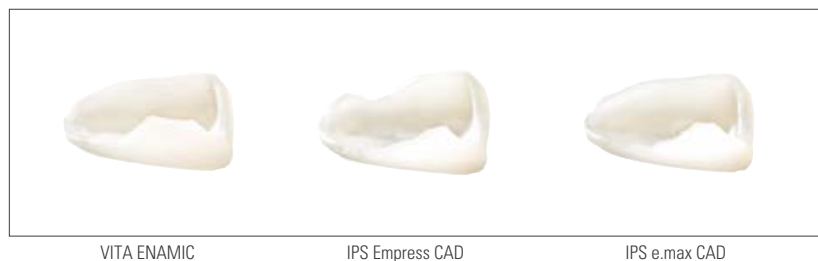
VITA ENAMIC, 25 x magnification, source: VITA R&D

IPS Empress CAD, 25 x magnification, source: VITA R&D
